Date: September 1, 2021
Project Number: 19-009
Subject: 301 Mission Retrofit Monitoring Report 017: Results as of August 30, 2021

Millennium Tower Perimeter Pile Upgrade: Instrumentation Monitoring Data
City and County of San Francisco, California

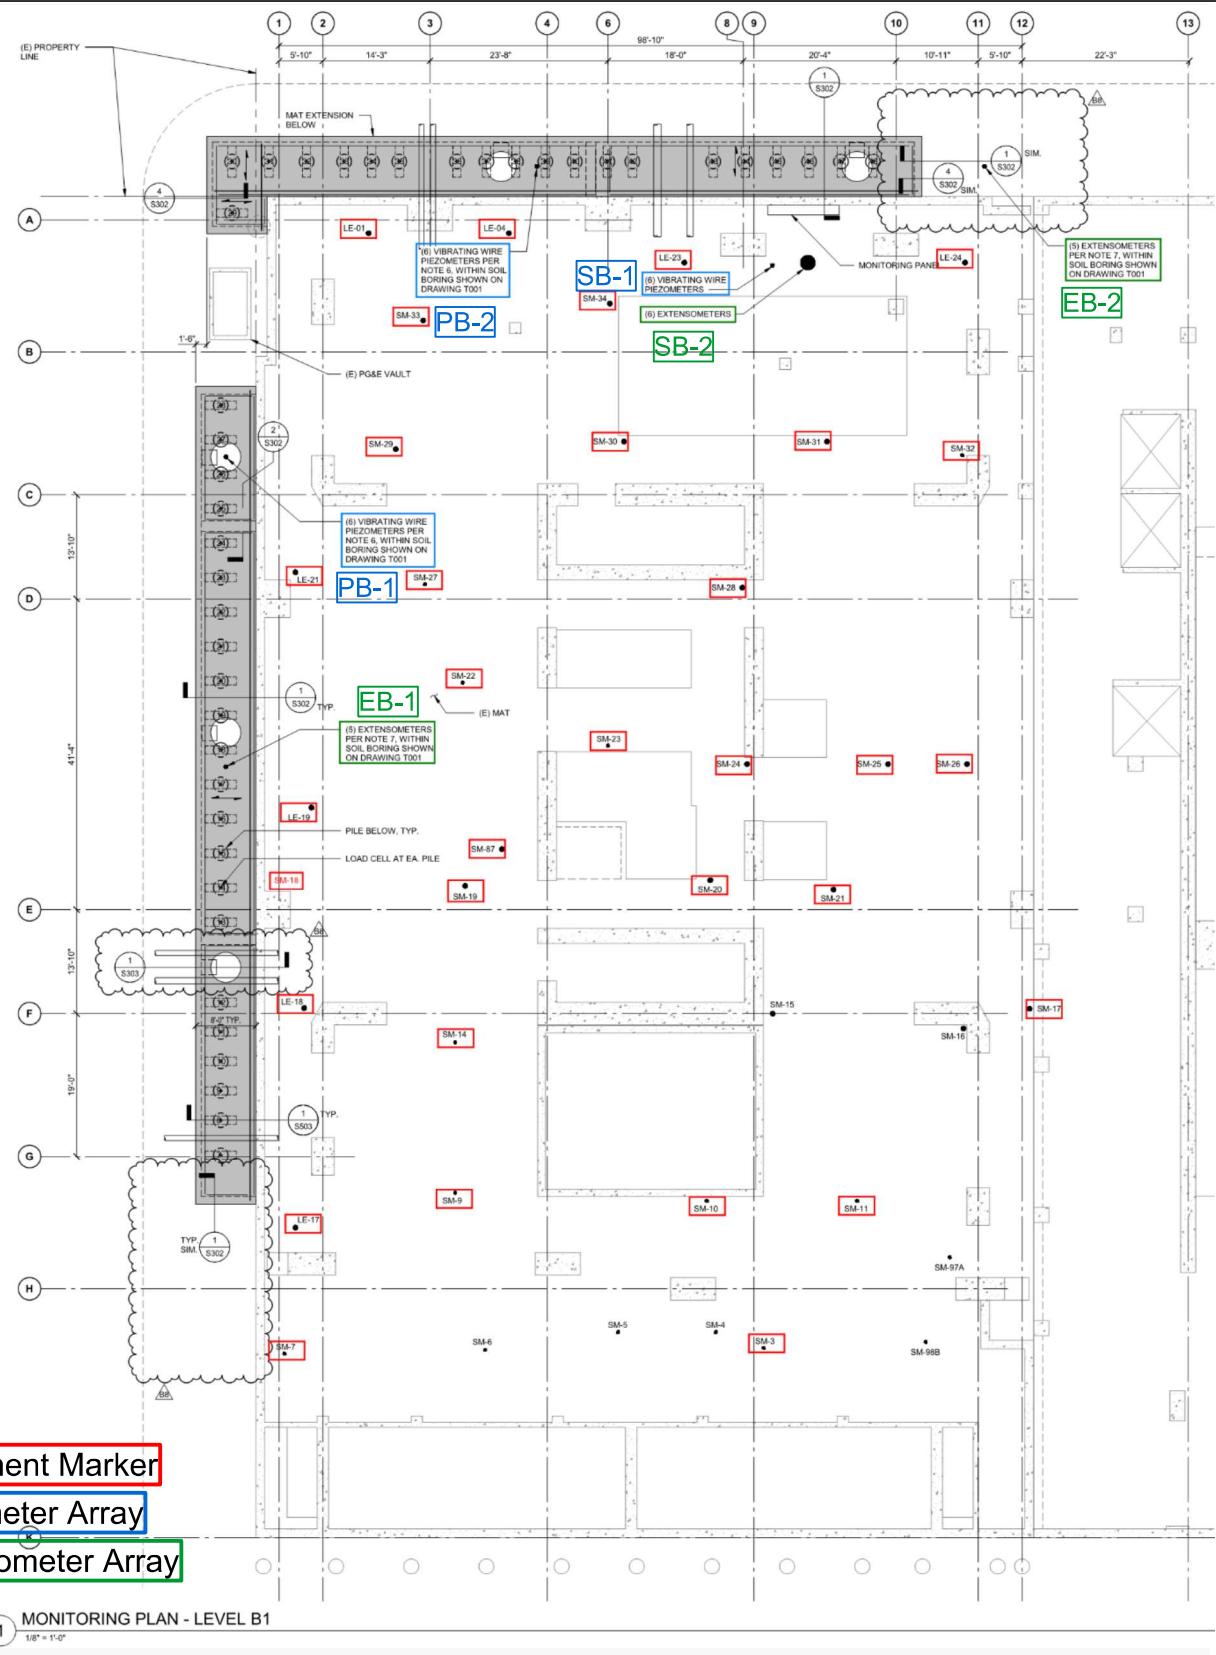
Project No: 19-009.00	Date: 7/26/2021	Created By: NBW	Checked By: DGM	Figure No: 018-01A
-----------------------	-----------------	-----------------	-----------------	--------------------

Figure 01 presents the instrument locations as referenced in later figures.

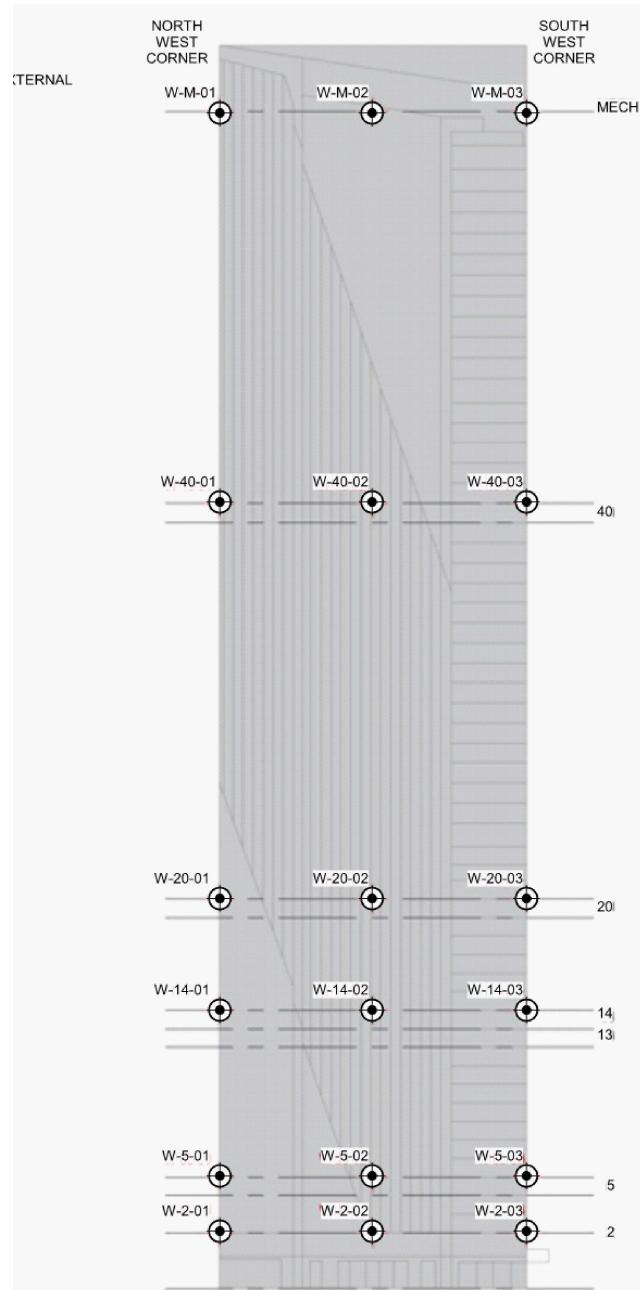
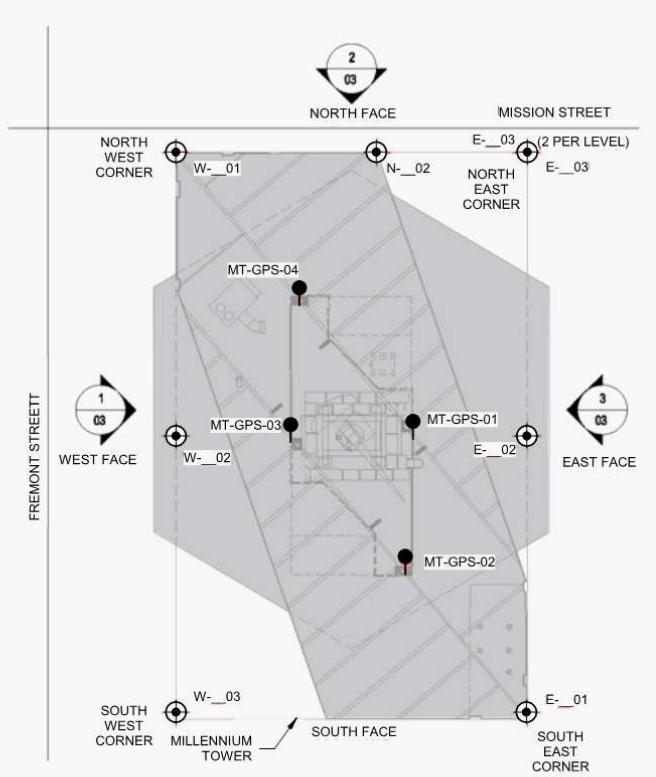
Project No: 19-009.00	Date: 7/26/2021	Created By: NBW	Checked By: DGM	Figure No: 018-01B
-----------------------	-----------------	-----------------	-----------------	--------------------

3 ROOF PLAN OF SURVEY PRISM INSTRUMENTATION

2 WEST ELEVATION OF SURVEY PRISM INSTRUMENTATION

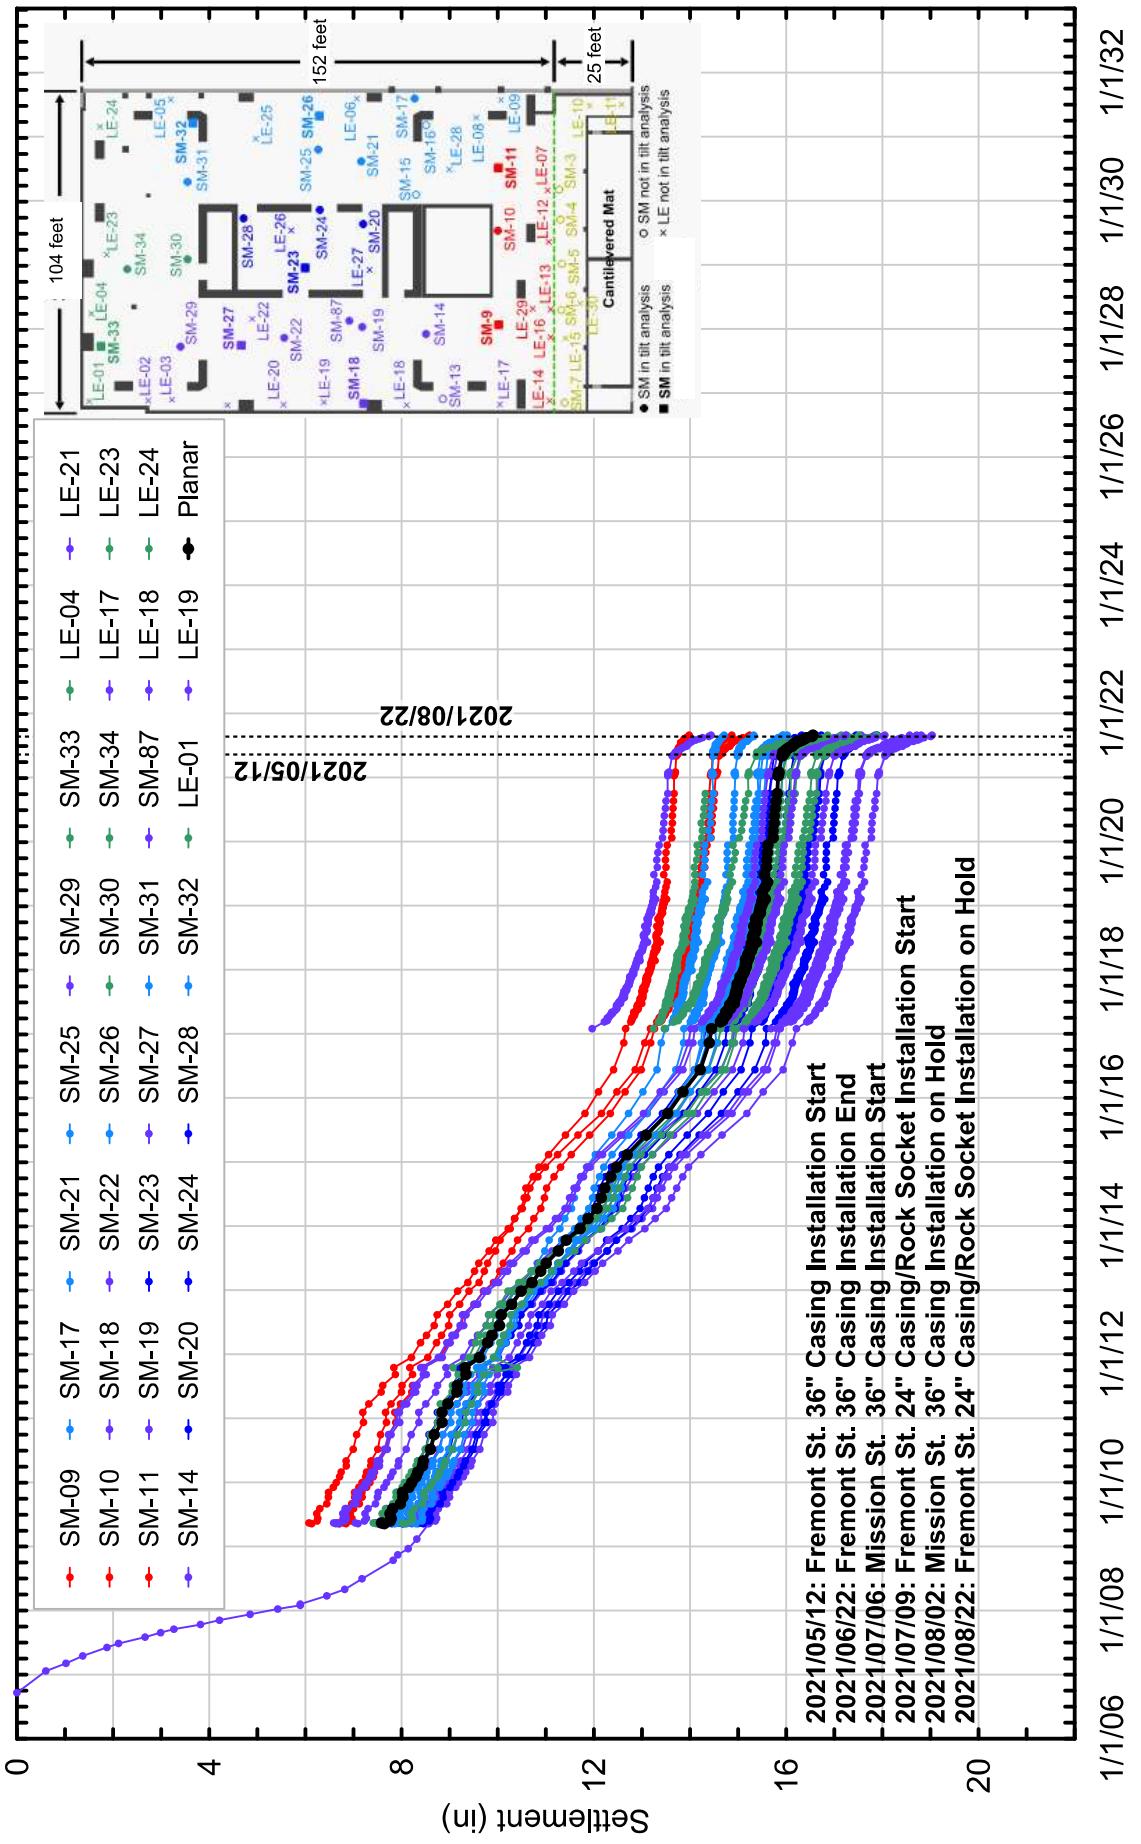
Project No: 19-009.00	Date: 9/1/2021	Created By: NBW	Checked By: DGM	Figure No: 018-02
SLATE GEOTECHNICAL CONSULTANTS

Figure 02 presents the historical settlement data interpreted from settlement markers installed on the B-1 Level of 301 Mission Tower. In addition, data from surveys performed during the retrofit are included. Figure 03A presents differential settlement data since the start of production pile installation (May 12, 2021; baseline readings on May 10, 2021) through August 30, 2021. Figure 03B presents differential settlement data since January 11, 2021, through August 30, 2021. Figure 04 presents current differential settlement contours (in inches) on August 30, 2021.

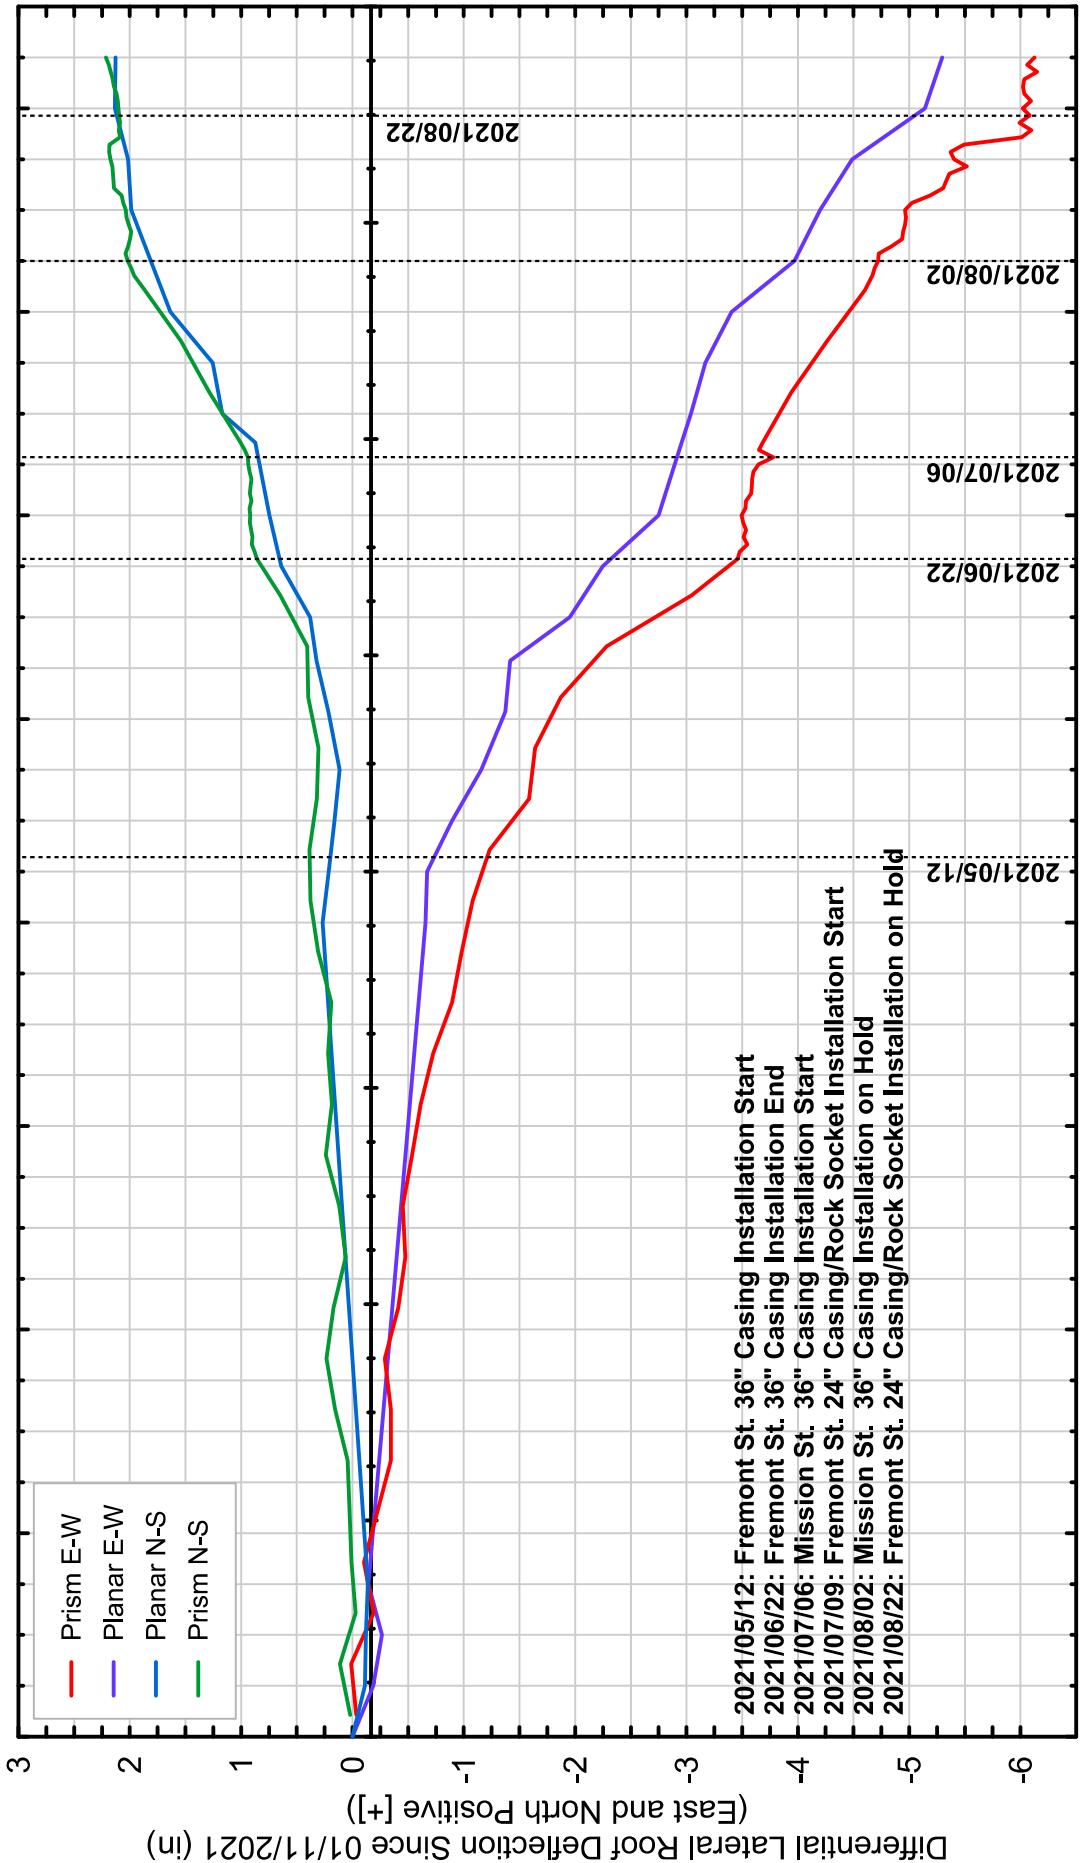
Project No: 19-009.00	Date: 9/1/2021	Created By: NBW	Checked By: DGM	Figure No: 018-06B
SLATE GEOTECHNICAL CONSULTANTS

2021/05/12: Fremont St. 36" Casing Installation Start
 2021/06/22: Fremont St. 36" Casing Installation End
 2021/07/06: Mission St. 36" Casing Installation Start
 2021/07/09: Fremont St. 24" Casing/Rock Socket Installation Start
 2021/08/02: Mission St. 36" Casing Installation on Hold
 2021/08/22: Fremont St. 24" Casing/Rock Socket Installation on Hold

DIFFERENTIAL LATERAL ROOF DEFLECTION DATA
SINCE 01/11/2021 THROUGH 08/30/2021

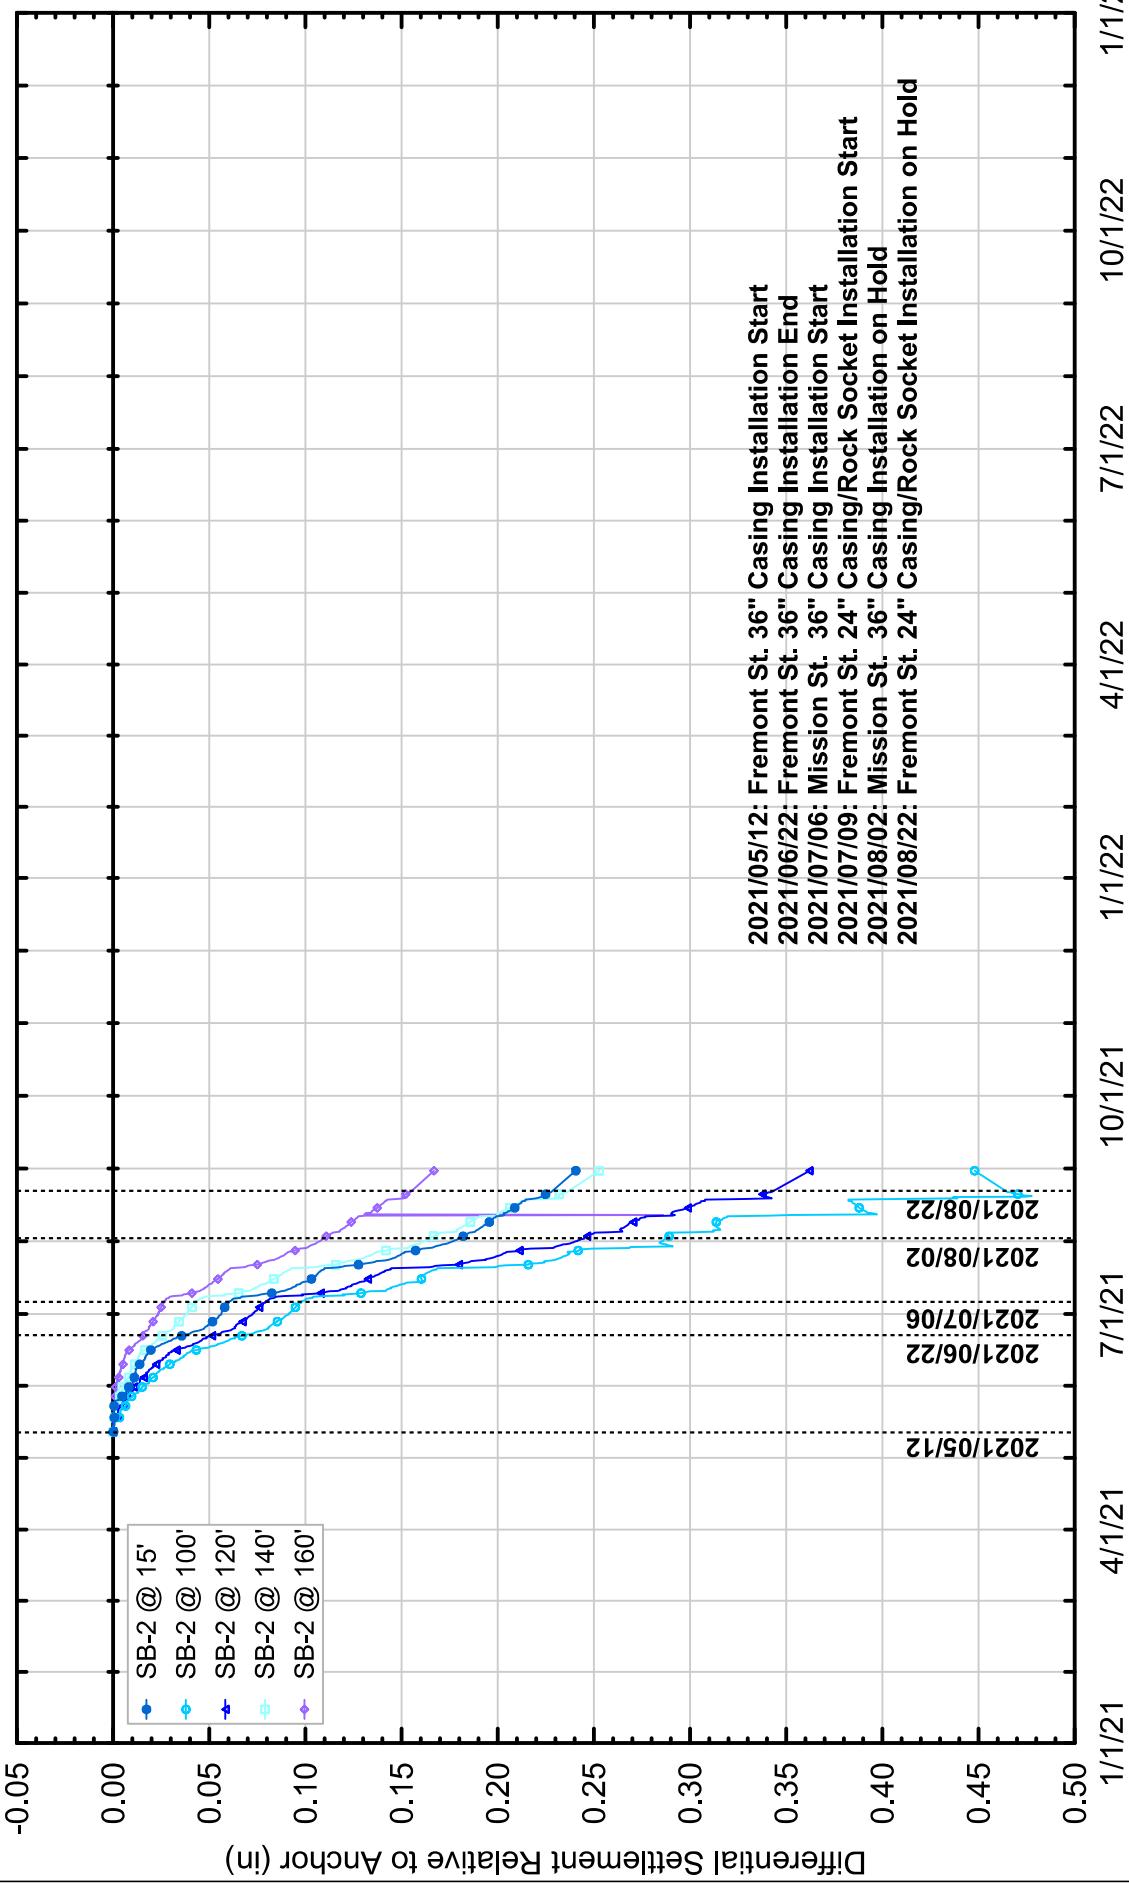
Project No: 19-009.00	Date: 9/1/2021	Created By: NBW	Checked By: DGM	Figure No: 018-10A
DIFFERENTIAL EXTENSOMETER DATA FROM WITHIN TOWER BASEMENT SINCE 01/01/2021 THROUGH 08/30/2021

Figure 10 presents extensometer data from within the Tower basement since the start of production pile installation (May 12, 2021) through August 30, 2021. Figure 11 presents extensometer data from Fremont

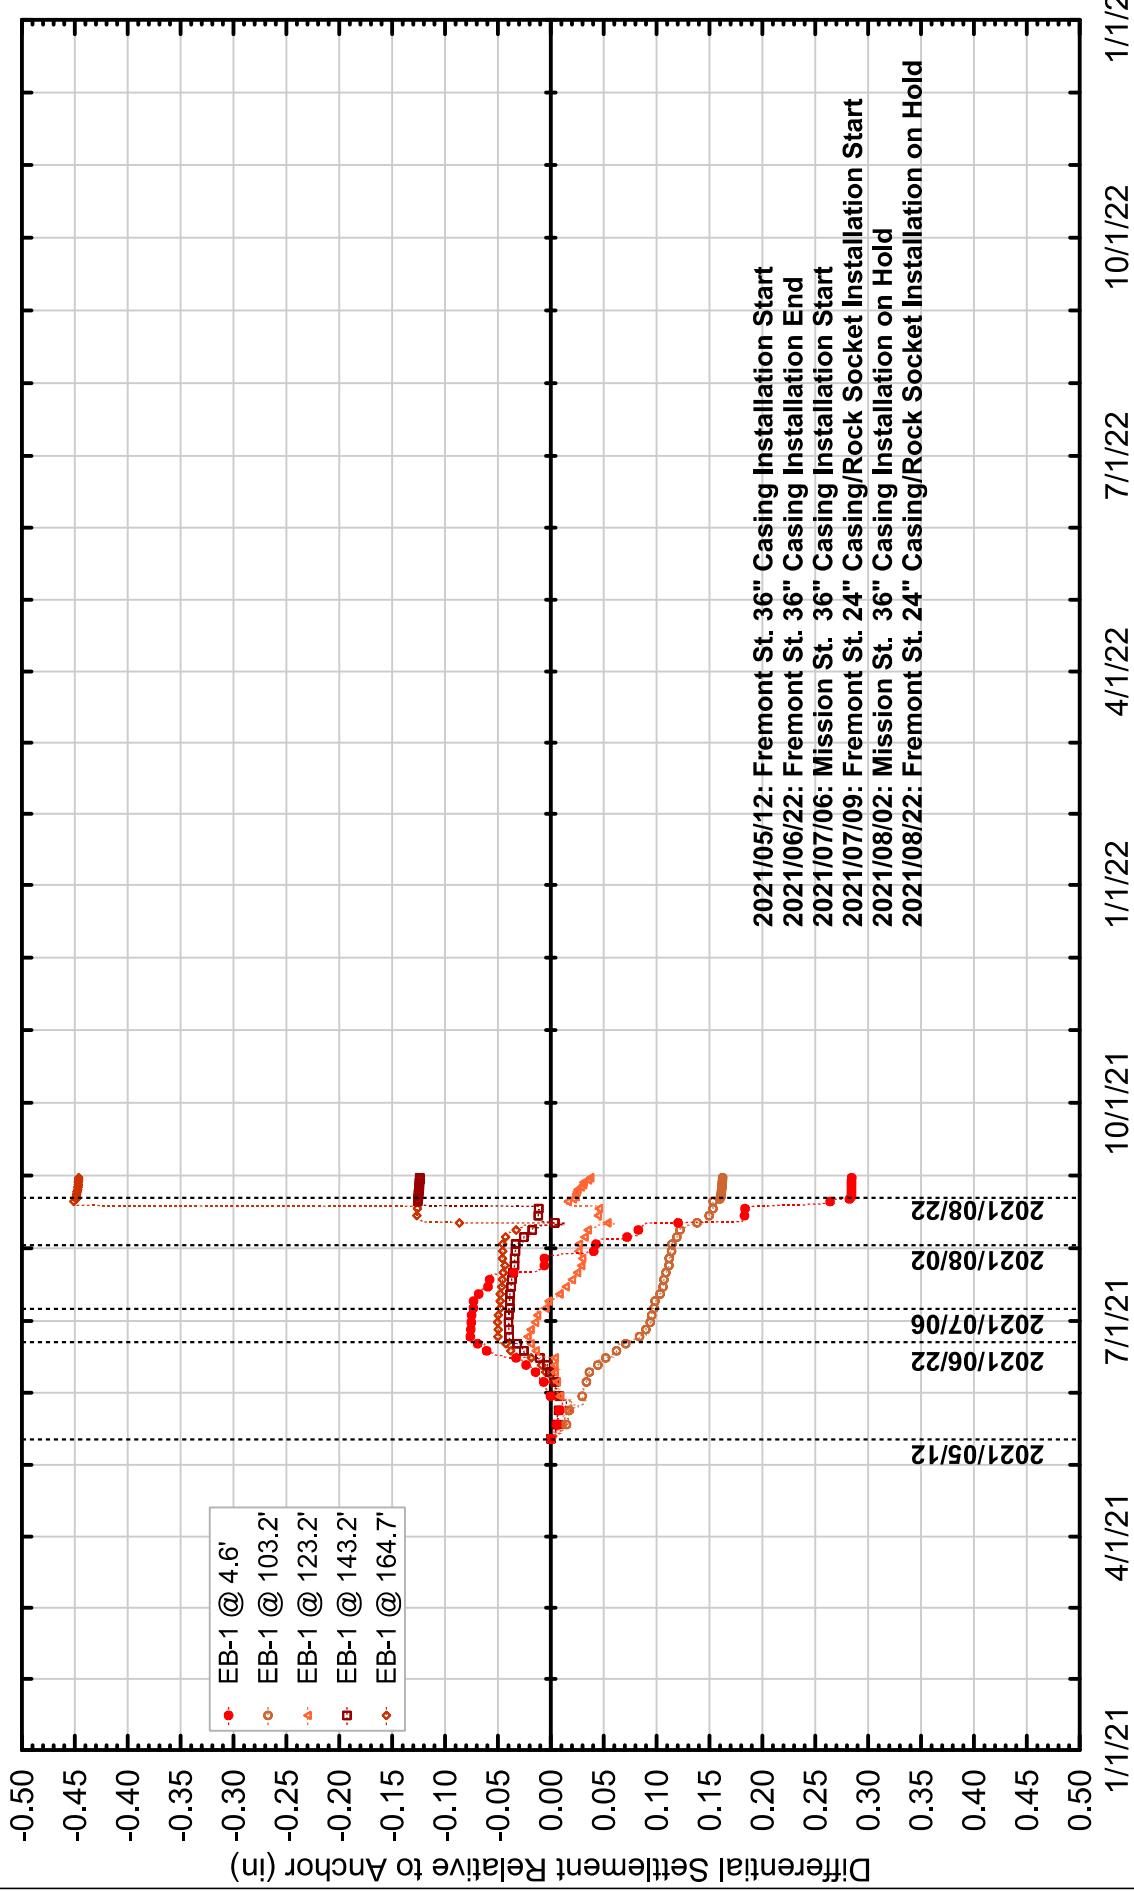
Project No: 19-009.00	Date: 9/1/2021	Created By: NBW	Checked By: DGM	Figure No: 018-11A
SLATE GEOTECHNICAL CONSULTANTS

DIFFERENTIAL EXTENSOMETER DATA FROM FREMONT STREET
SINCE 01/01/2021 THROUGH 08/30/2021

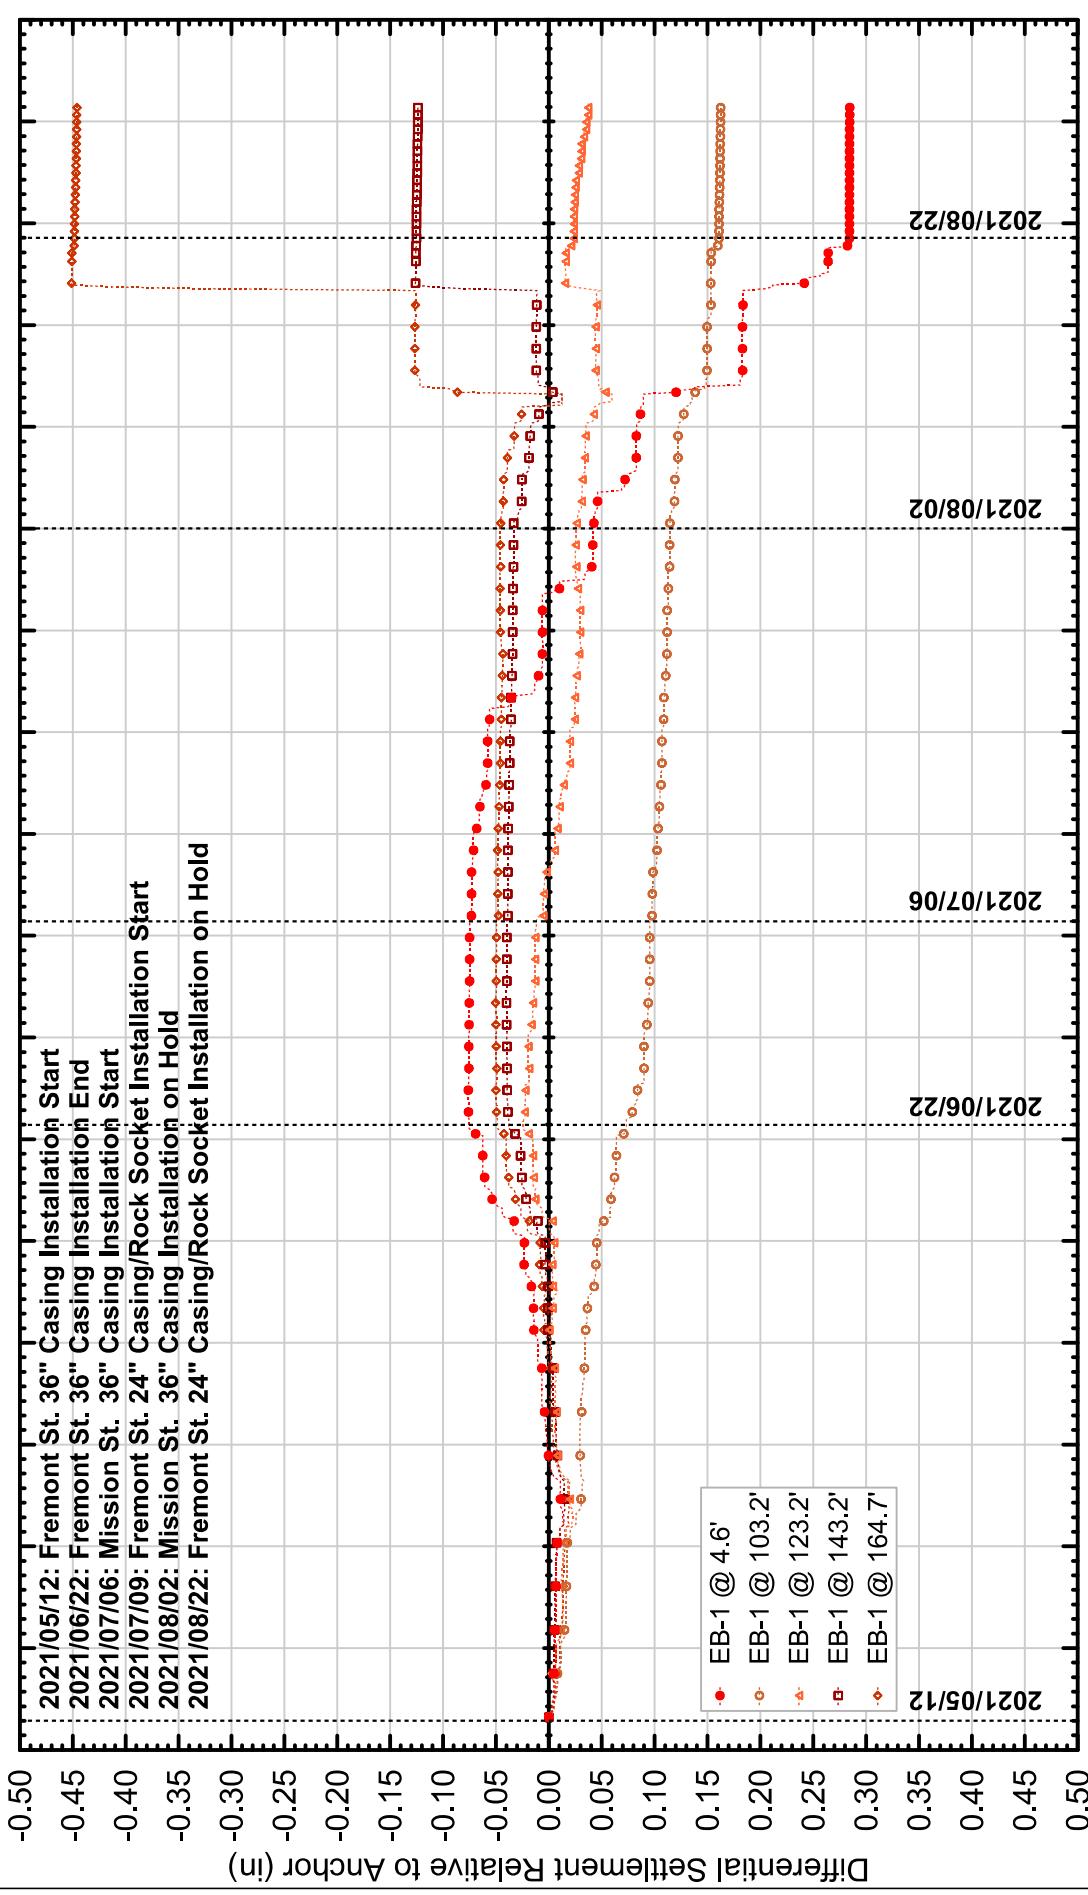
Project No: 19-009.00	Date: 9/1/2021	Created By: NBW	Checked By: DGM	Figure No: 018-11B
-----------------------	----------------	-----------------	-----------------	--------------------

Street since the start of production pile installation (May 12, 2021) through August 30, 2021. Figure 12 presents extensometer data from Mission Street since the start of production pile installation (May 12, 2021) through August 30, 2021.

DIFFERENTIAL EXTENSOMETER DATA FROM FREMONT STREET
SINCE 05/10/2021 THROUGH 08/30/2021

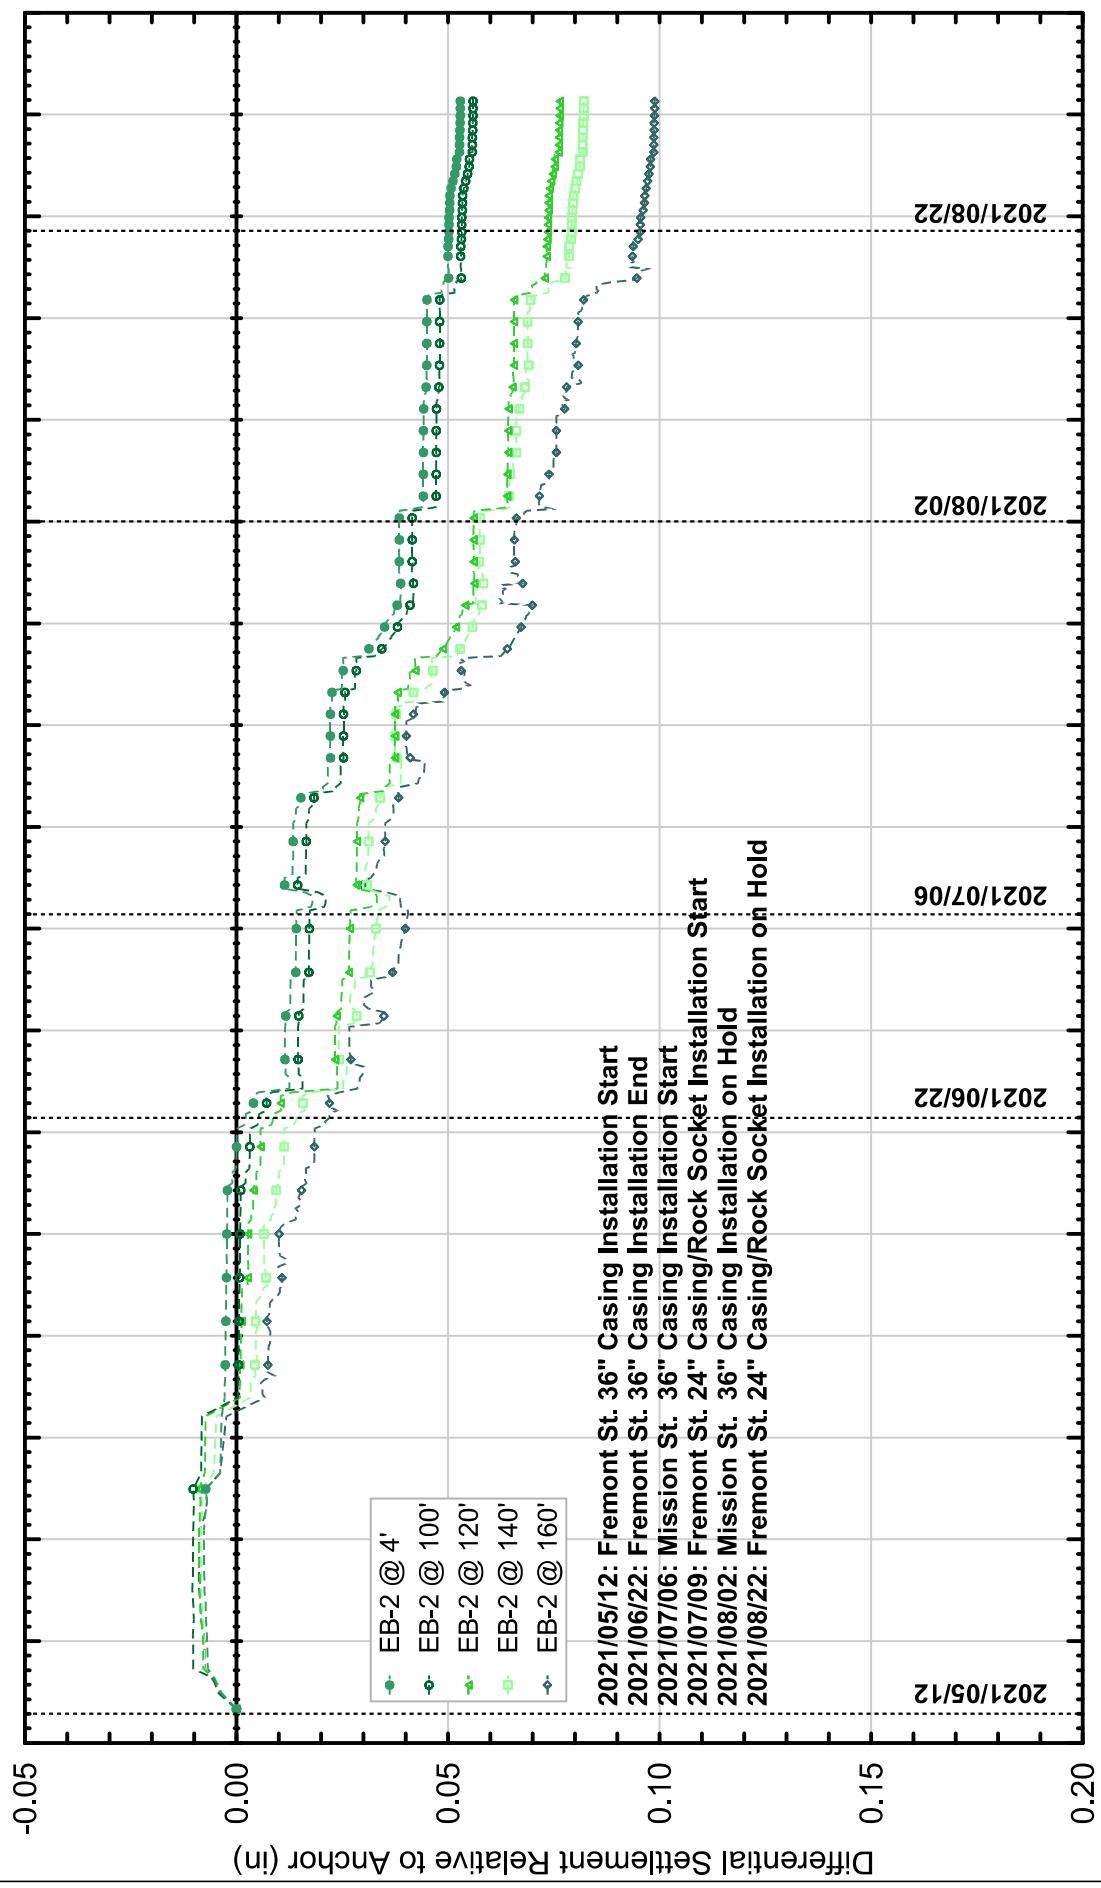
Project No: 19-009.00	Date: 9/1/2021	Created By: NBW	Checked By: DGM	Figure No: 018-12B
-----------------------	----------------	-----------------	-----------------	--------------------

DIFFERENTIAL EXTENSOMETER DATA FROM MISSION STREET
SINCE 05/10/2021 THROUGH 08/30/2021
